# COMPOUND COSTS OF INSTRUMENT INACCURACIES

## **Case Study**

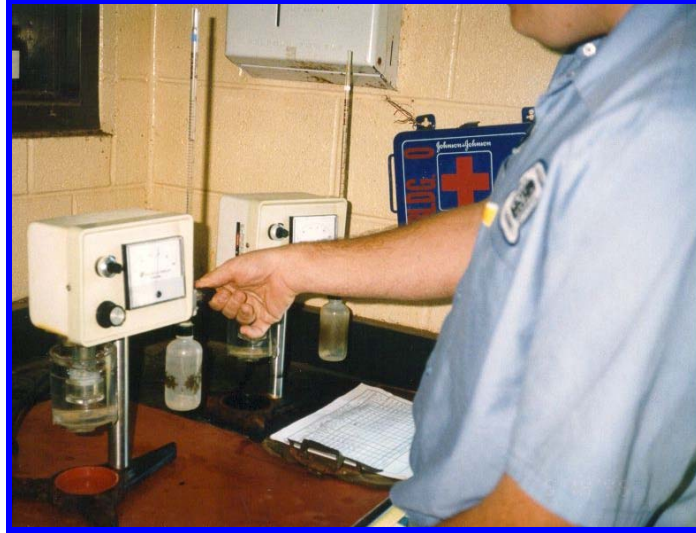
**Manual Titration for Laboratory Analysis**

The time delay between the analyzer's reading at the time the sample was taken and the time it took staff to perform analysis in the laboratory before recalibrating was significant enough to have changes in the process, therefore producing errors in the analyzer calibration and analyzer output readings.

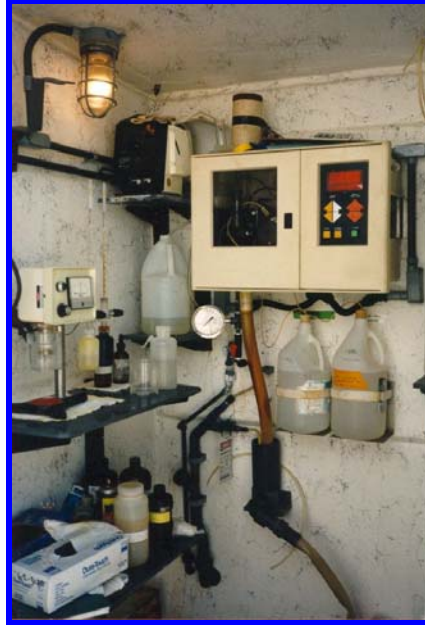
### **Chlorine Residual Analyzer Installation With Reagents and Laboratory Analysis Equipment**

The replacement analyzer cost approximately \$5,000 and was installed per the manufacturer's recommendations. Total installation costs exceeded \$20,000 due to special sample pumps, additional sample piping, and sample conditioning. The replacement analyzer was also installed in a small structure that contained equipment for laboratory analysis.

This laboratory equipment located at the analyzer installation site would eliminate errors in analyzer calibration.

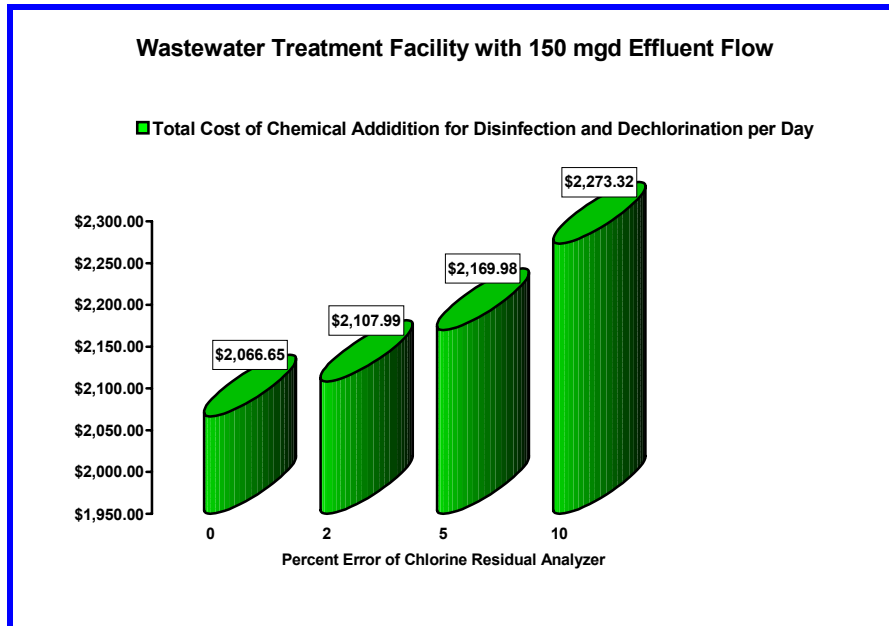
**Graph 1—Chemical Costs Per Day**

Graph 1 shows four columns, each representative of the total cost of chemical addition for chlorination and dechlorination per day compared to chlorine residual analyzer errors of 0, 2, 5, and 10%. The baseline column of \$2,066.65 at 0% error would be the minimum cost to chlorinate and dechlorinate if no error occurred when measuring the chlorine residual.

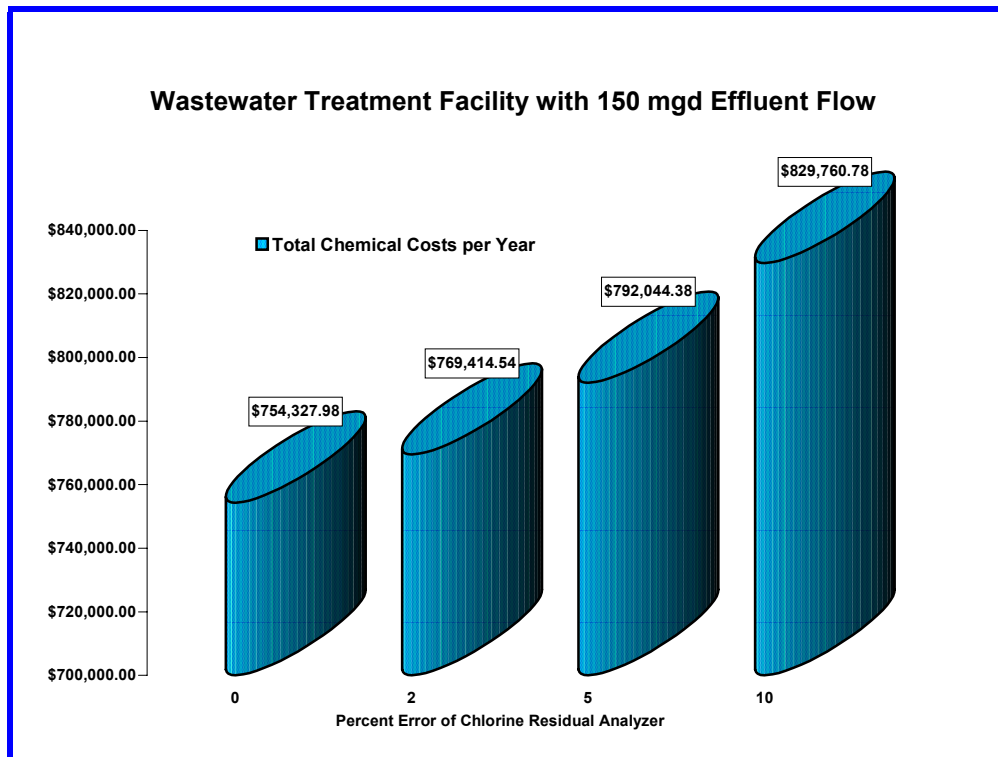
**Graph 2—Chemical Costs Per Year**

Graph 2 depicts the annual costs of chlorination and dechlorination compared to the percent error from the chlorine residual analyzer.

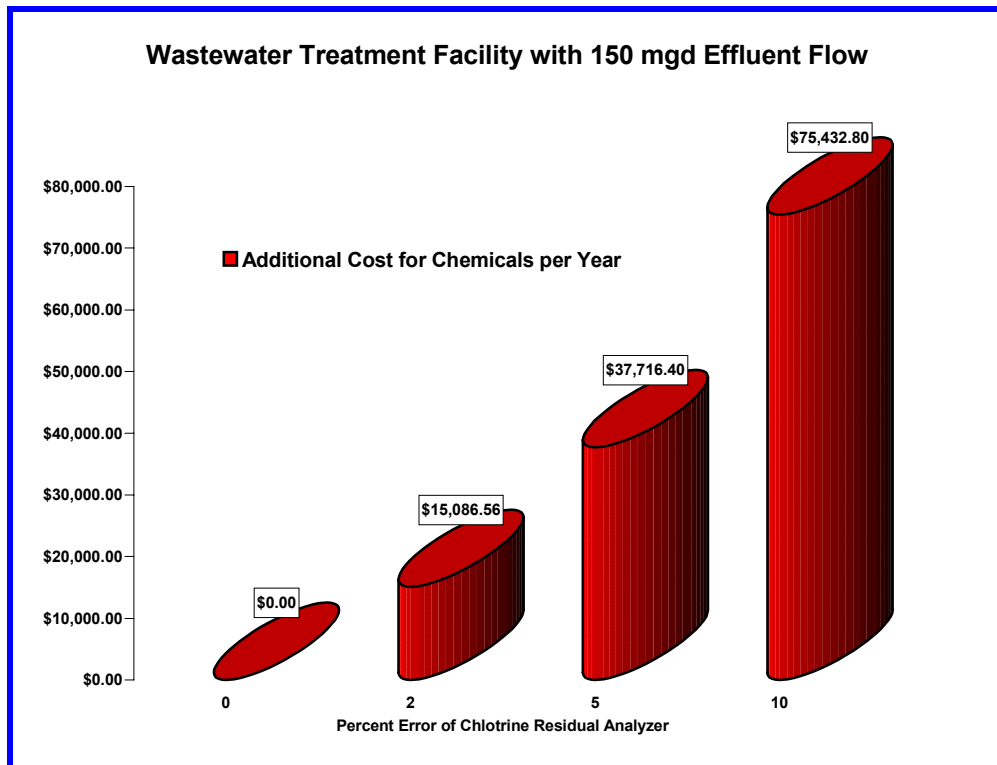
**Graph 3—Additional Chemical Costs Per Year**

Graph 3 shows additional annual costs of chlorination and dechlorination as the percent of error increases in the chlorine residual measurement.
