# COMPOUND COSTS OF INSTRUMENT INACCURACIES

## **Case Study**

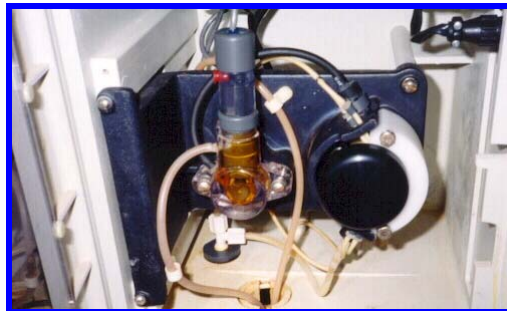
**Inside Chlorine Residual Analyzer  
Sample Cell and Reagent Pump**

The replacement analyzer cost approximately \$5,000 and was installed per the manufacturer's recommendations. Total installation costs exceeded \$20,000 due to special sample pumps, additional sample piping, and sample conditioning. The replacement analyzer was also installed in a small structure that contained equipment for laboratory analysis.

This laboratory equipment located at the analyzer installation site would eliminate errors in analyzer calibration.
